# **CASE SUMMARY • CERTIFICATE OF APPROPRIATENESS (COA)**

Historic Preservation Commission Evidentiary Hearing • August 14, 2025

Address:	23 North Front Street	District:	Commercial Business District-Historic
			District Overlay (CBD-HDO)
Request:	Replace storefront		
Property	James Goodnight, Harpoon	Agent:	Laurie Jackson
Owner:	Properties, LLC		2117 Wrightsville Ave
	2108 Clark Avenue		Wilmington, NC 28401
	Raleigh, NC 27605		_

# 23 N. FRONT ST. PROPOSED NEW WORK

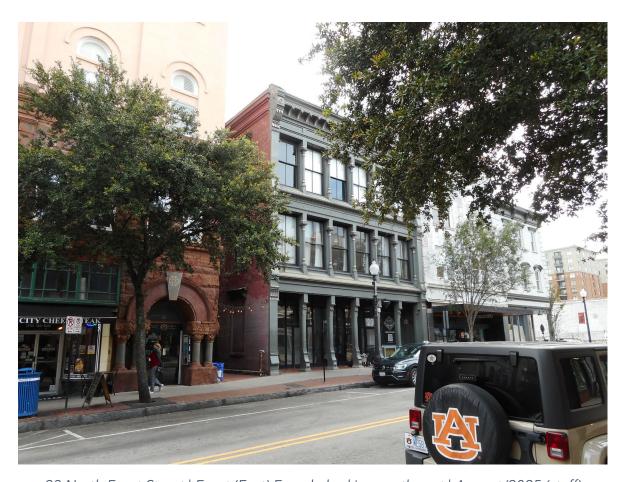
23 North Front Street | Front (East) Façade looking northwest | August/2025 (staff)

The applicant proposes to replace the existing non-original storefront on the front (east) elevation. The proposed work to the rear of the building has been withdrawn by the applicant and will be resubmitted at a later time.

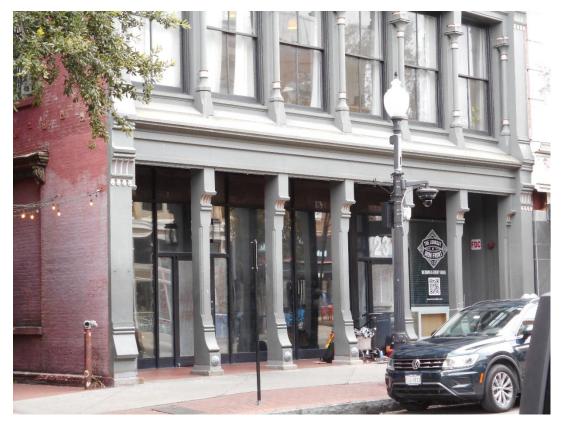
23 North Front Street | Detail of first story of front (east) façade looking northwest | August/2025 (Staff)

- 5. The applicant proposes the following demolitions:
  - a. Remove the non-original storefront and entry doors on the first floor of the front (east) elevation.

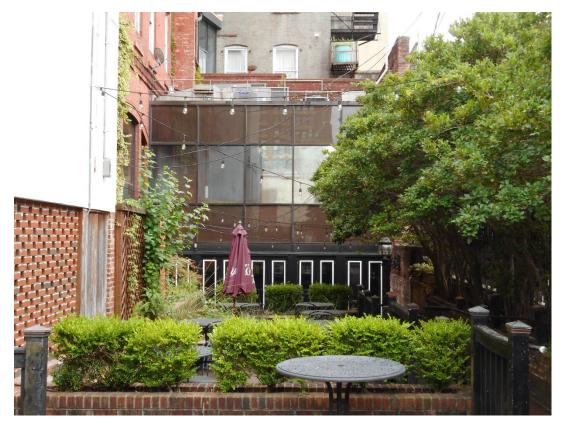
23 North Front Street | Rear addition storefront to be replaced looking south | August/2025 (Staff)

- b. Remove the existing storefront glazing on the first floor of the rear addition.
  - c. Remove the French doors at the basement level of the rear addition.

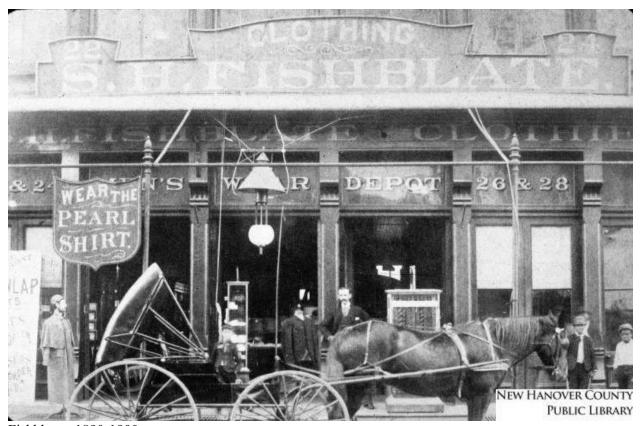
Fishblates, 1890-1900

A historic photograph of the first floor elevation dated 1890-1900 is provided on the following page. As originally constructed, a storefront with transom above runs between the pilasters. Large wood doors with ¾ lites and a wood panel below can be seen at either side of the building. Design for the new entrances and storefront with transom is based on the historic photograph. There are also two infilled masonry openings on the south elevation of the first floor, along Ewing's Alley. This alley has been abandoned by the City and half of it now belongs to the building owner.

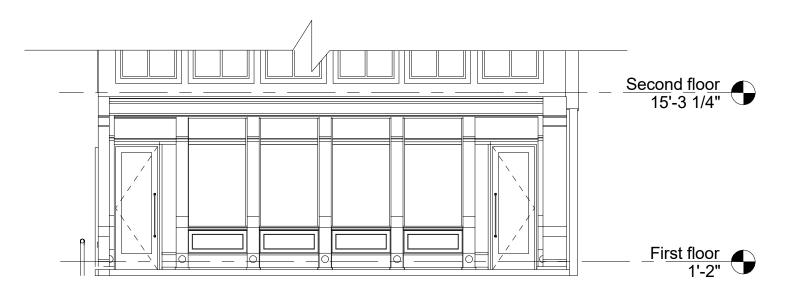
SK-1

EAST ELEVATION, FIRST FLOOR

SCALE: 1/8" = 1'-0"

- a. The same general dimensions and datum lines will be used the transom and glazing.
  - b. On the south end of the front (east) elevation, a new recessed entry will be constructed for first floor tenant access.

- c. The recessed entry for the basement, second, and third floor tenants will be through a new recessed entry on the north side of the front (east) elevation.

- d. To meet code requirements, the new entries will have a single door approximately 3'-6" x 10' in size with a full height sidelight. The doors will be wood with ¾ lite and panel below. The new doors will be approximately the same height as shown in the historic photograph.

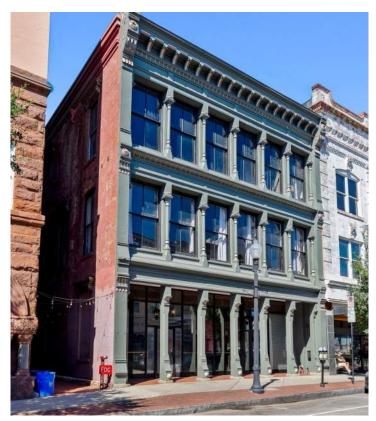
**01** - Existing east elevation along N. Front St.

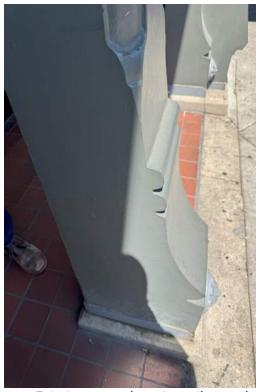
02 - Existing east elevation pilaster detail

- 1. The proposed replacement windows will be clear with no tint.
- 2. The new storefront system shall be installed in a manner that will result in no damage to the existing iron pilasters.
- 3. All construction shall comply with the regulations and requirements imposed by the Land Development Code and other applicable federal, state, or local law, ordinance, or regulation, including the North Carolina Building Code. All required permits shall be obtained.
- 4. Changes to the project from that described in the application and submittals, shall be reviewed by the Historic Preservation Commission, or if minor in nature as specified in the Wilmington Design Standards for Historic Districts and Landmarks, by staff through the administrative bypass process.

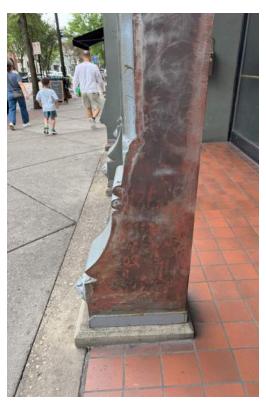
03 - Existing east elevation pilaster detail

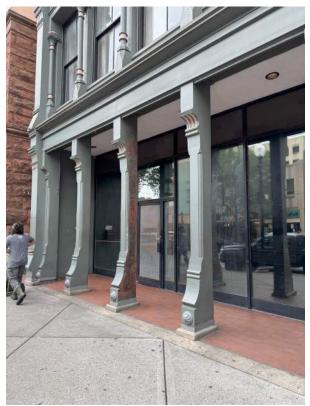
**04** - Existing storefront detail
