CERTIFICATE OF APPROPRIATENESS APPLICATION

MAJOR WORK

112 S 7th Street Major Works Application

Project Narrative – Chimney Removal Request

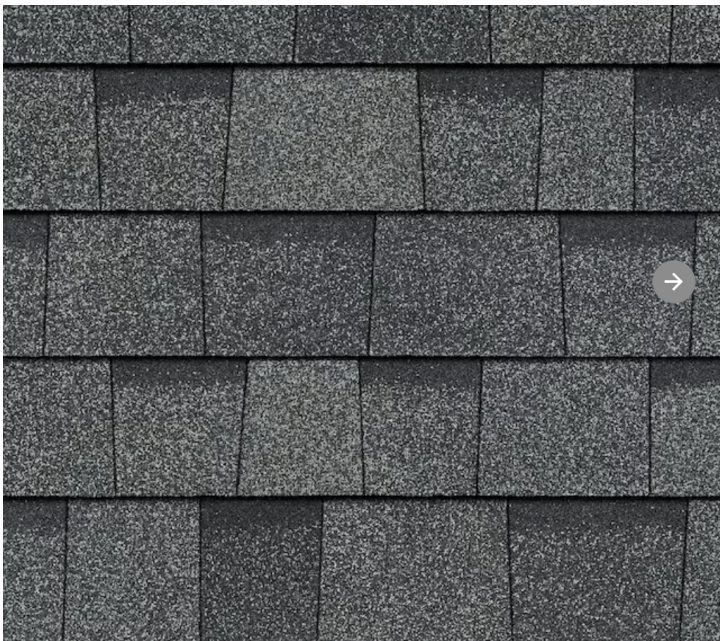
Shingle Material: Owens Corning Estate Grey. This is an exact match for the existing roof

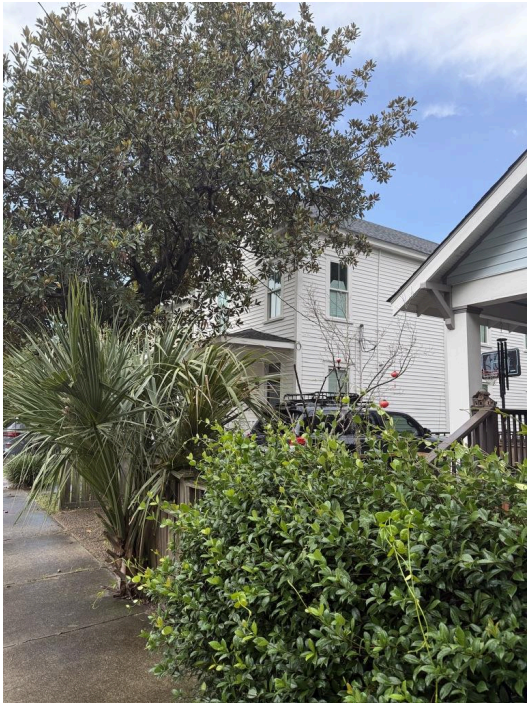
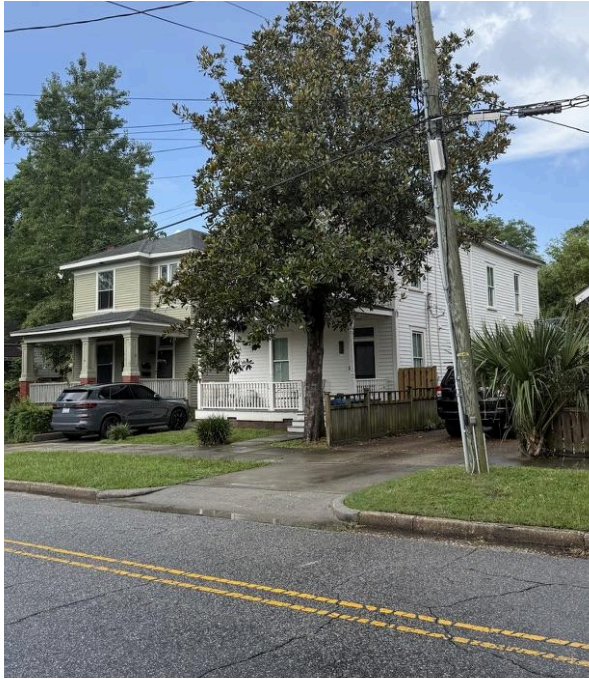
Views of the house coming from Dock Street - neither chimney visible at all from either side of the street:

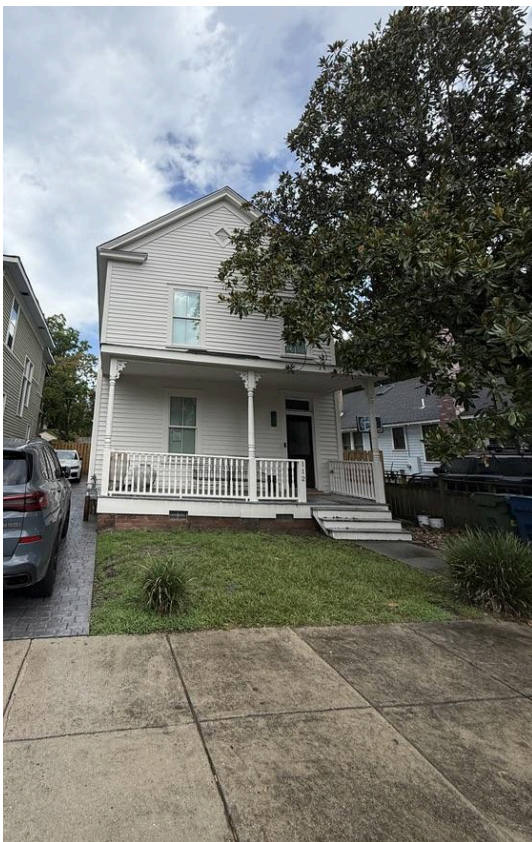
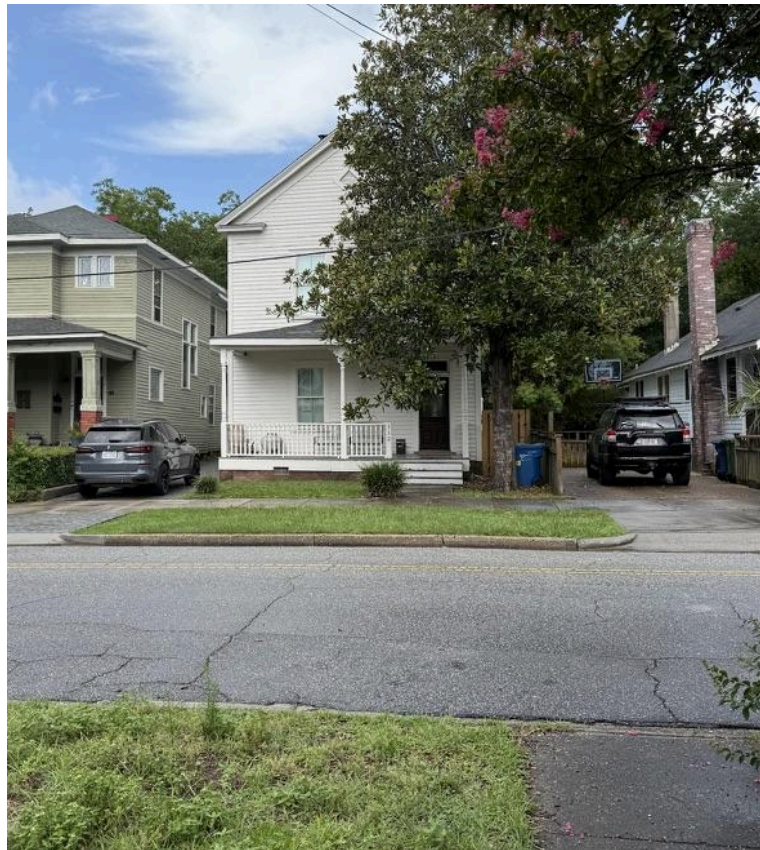
Views from directly in front of the house - back chimney entirely invisible and front chimney almost entirely obstructed from both sides of the street

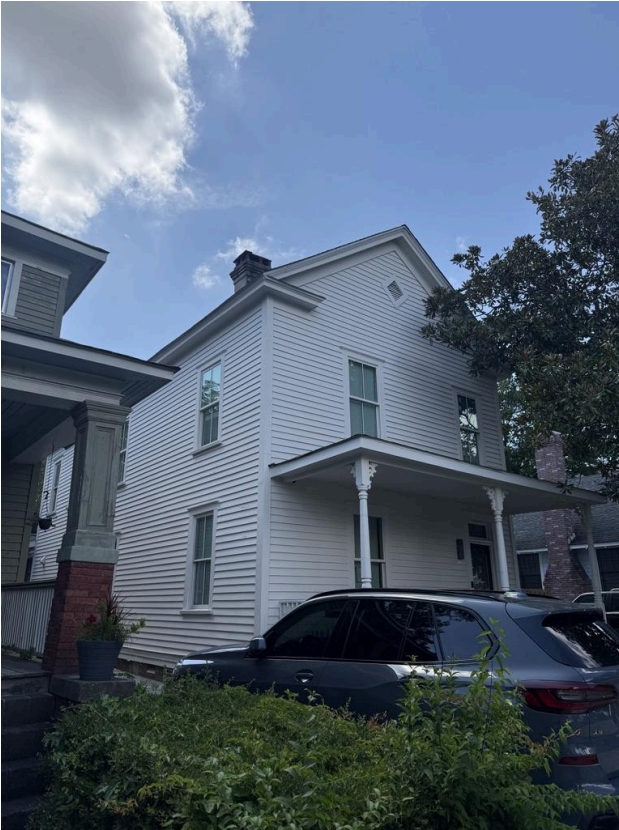
Views coming from Orange St - back chimney entirely invisible, front chimney largely obstructed

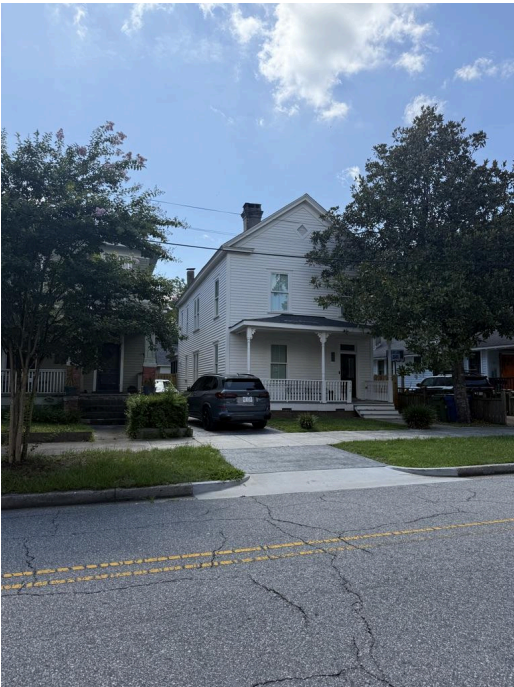
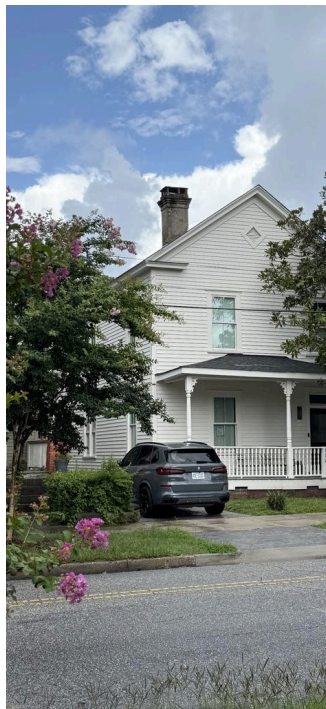
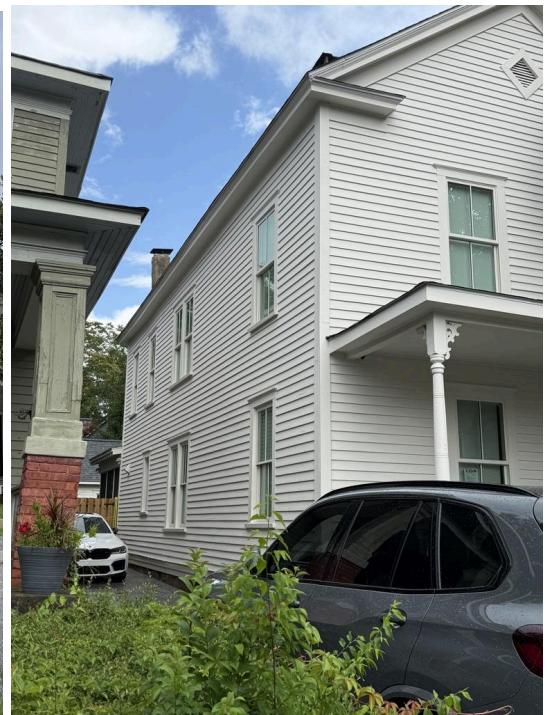
There are only two very small parts of the street from which both chimneys and/or the front chimney in its entirety can be seen from the street - when standing either in our driveway or across the street at a very precise angle:

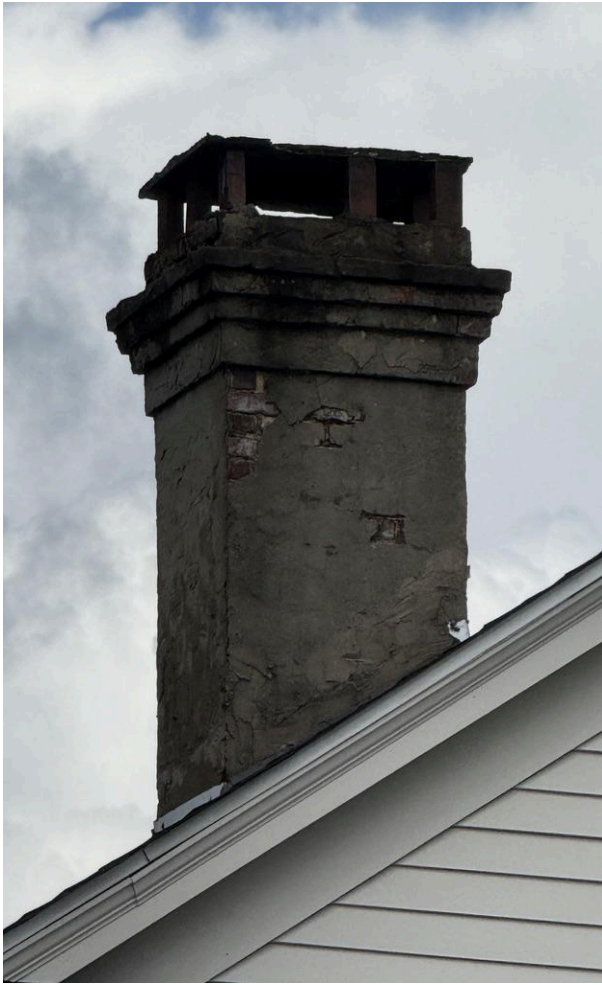
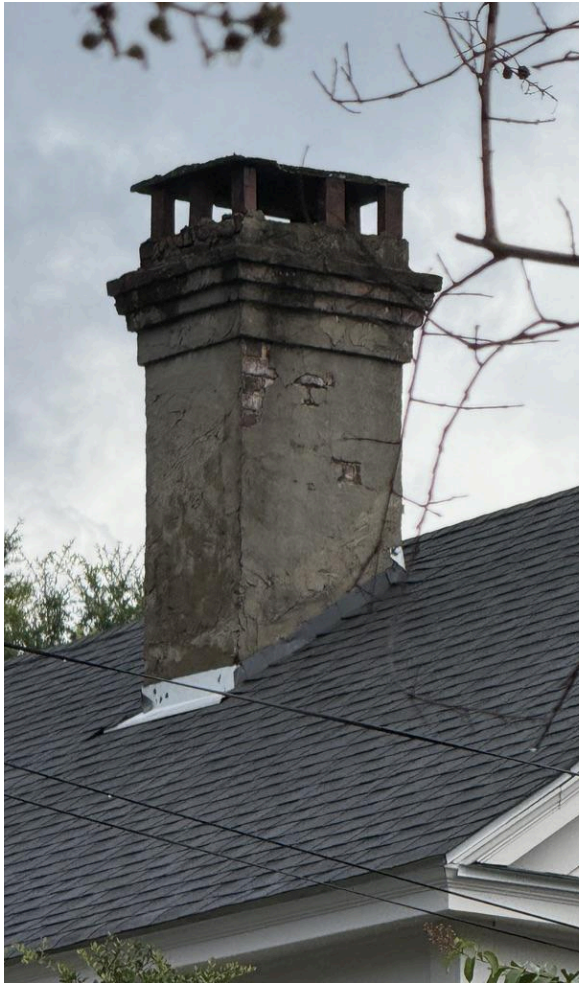
Closer view of the chimneys to show their state of disrepair. The back chimney is not original to the house (was added at some point during an addition; front chimney is primarily made of deteriorating concrete at this point and does not show any defining features or brickwork).

We are requesting approval to remove both chimney stacks from our home due to safety, structural, and practical concerns. Neither chimney is currently functional, nor can they be restored to safe or operable condition in the future. One is connected to decorative (non-working) fireplaces; the other was previously used for a kitchen cookstove and is now fully enclosed behind drywall.

After professional interior and exterior inspection, both chimneys were found to have significant deterioration and are actively contributing to water intrusion in the house. This has led to interior damage and increased risk of mold - particularly concerning in our baby daughter's nursery and other affected rooms. Patriot Roofing evaluated both chimneys and advised that removing the deteriorated stacks and patching the roof would be the most cost-effective and reliable solution, at \$450 per chimney. In contrast, fully rebuilding both chimneys - despite their permanent inoperability - would require major structural work at a cost of \$5,000–\$6,000 per chimney (approximately \$12,000 total).

We understand and respect the committee's guidelines for chimney preservation, especially where original masonry and design elements like corbelling, chimney pots, or historic brickwork are present. In our case, the chimneys do not meet those criteria. The rear chimney is entirely concrete or has been fully parged over, with no visible original masonry. The front chimney has a small section of exposed brick near the top, but the majority of the structure is concrete or has been heavily altered. Neither chimney includes original design features such as decorative brick detailing or clay pots, and both appear to have undergone significant modification in prior decades. Based on inspection and visible condition, we believe neither chimney qualifies as a character-defining architectural feature under the committee's preservation standards.
