## BOARD OF ADJUSTMENT REQUEST FOR VARIANCE

**Attachment to Variance Application**  
**Avenue Flats, N. Kerr Avenue, Wilmington**

**Reason for Variance Request**

### Tree Assessments of the Wilmington Site at S Kerr Ave.

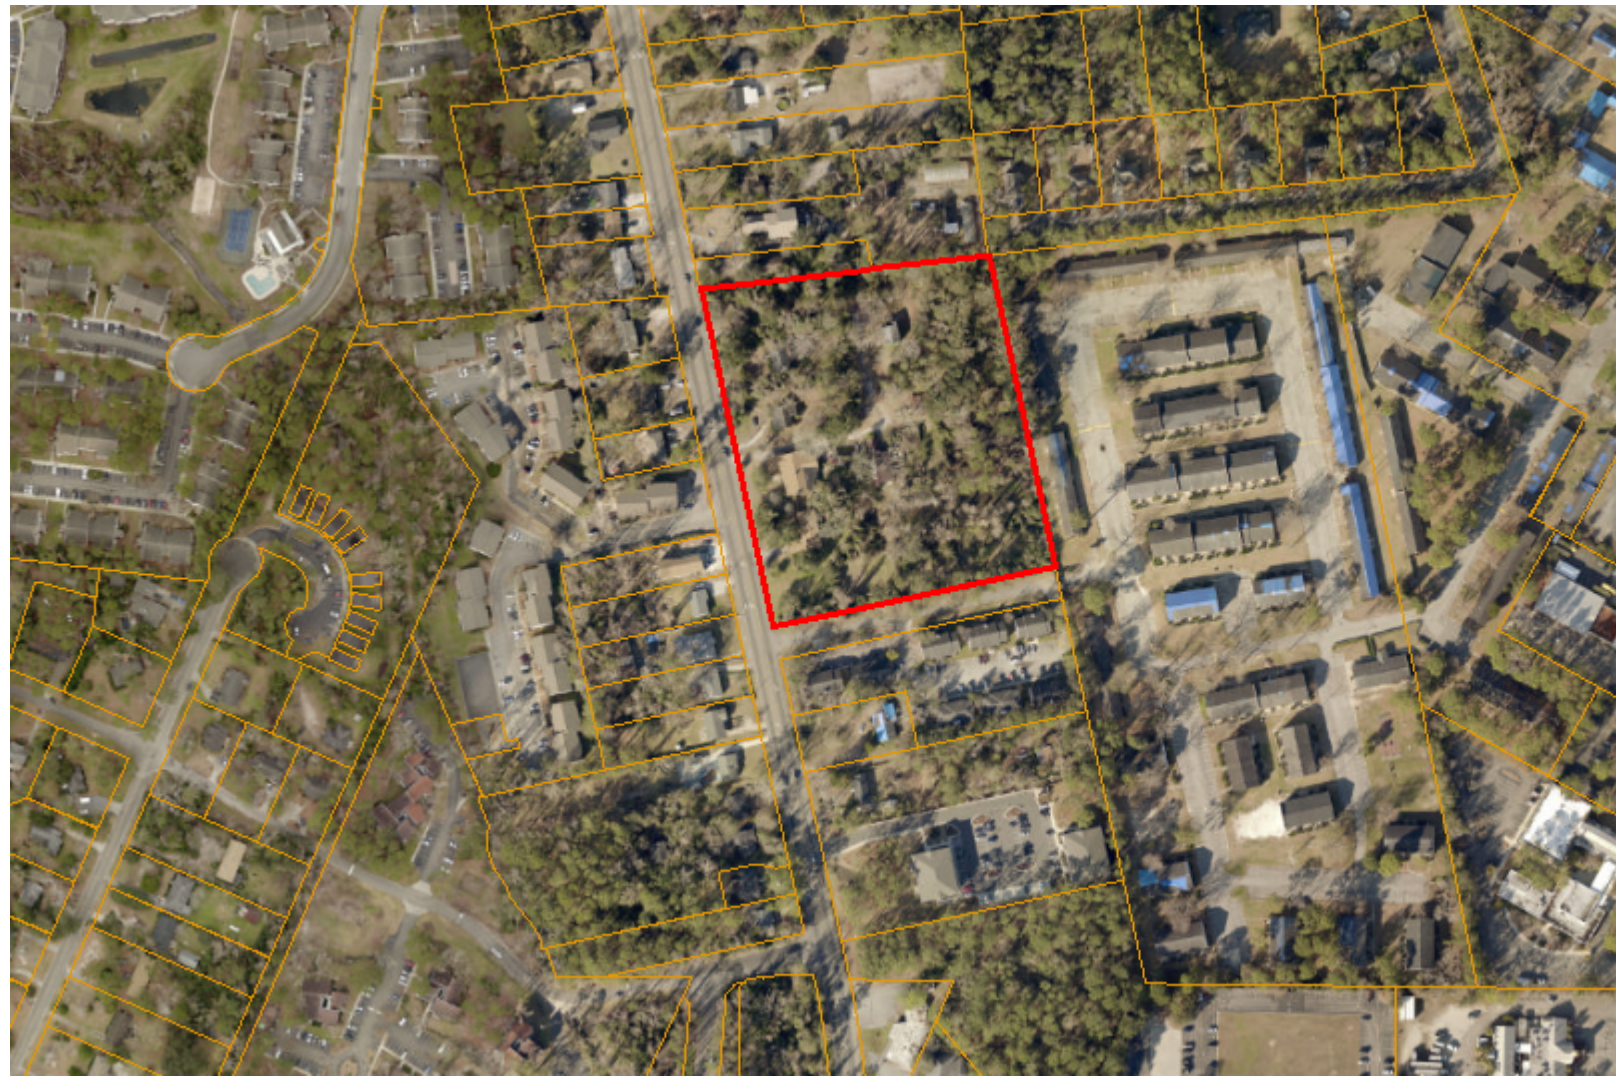
*Location of decay pocket  
at base of tree trunk*

**Photo 3 (Right)** - Close of view of tree from the bottom of bank (pond side). The location of the decay pocket described in the arborist's report is identified. This photo also emphasizes the tree's growth habit away from the existing pond and compromised anchoring roots due to steep topography at the pond bank.

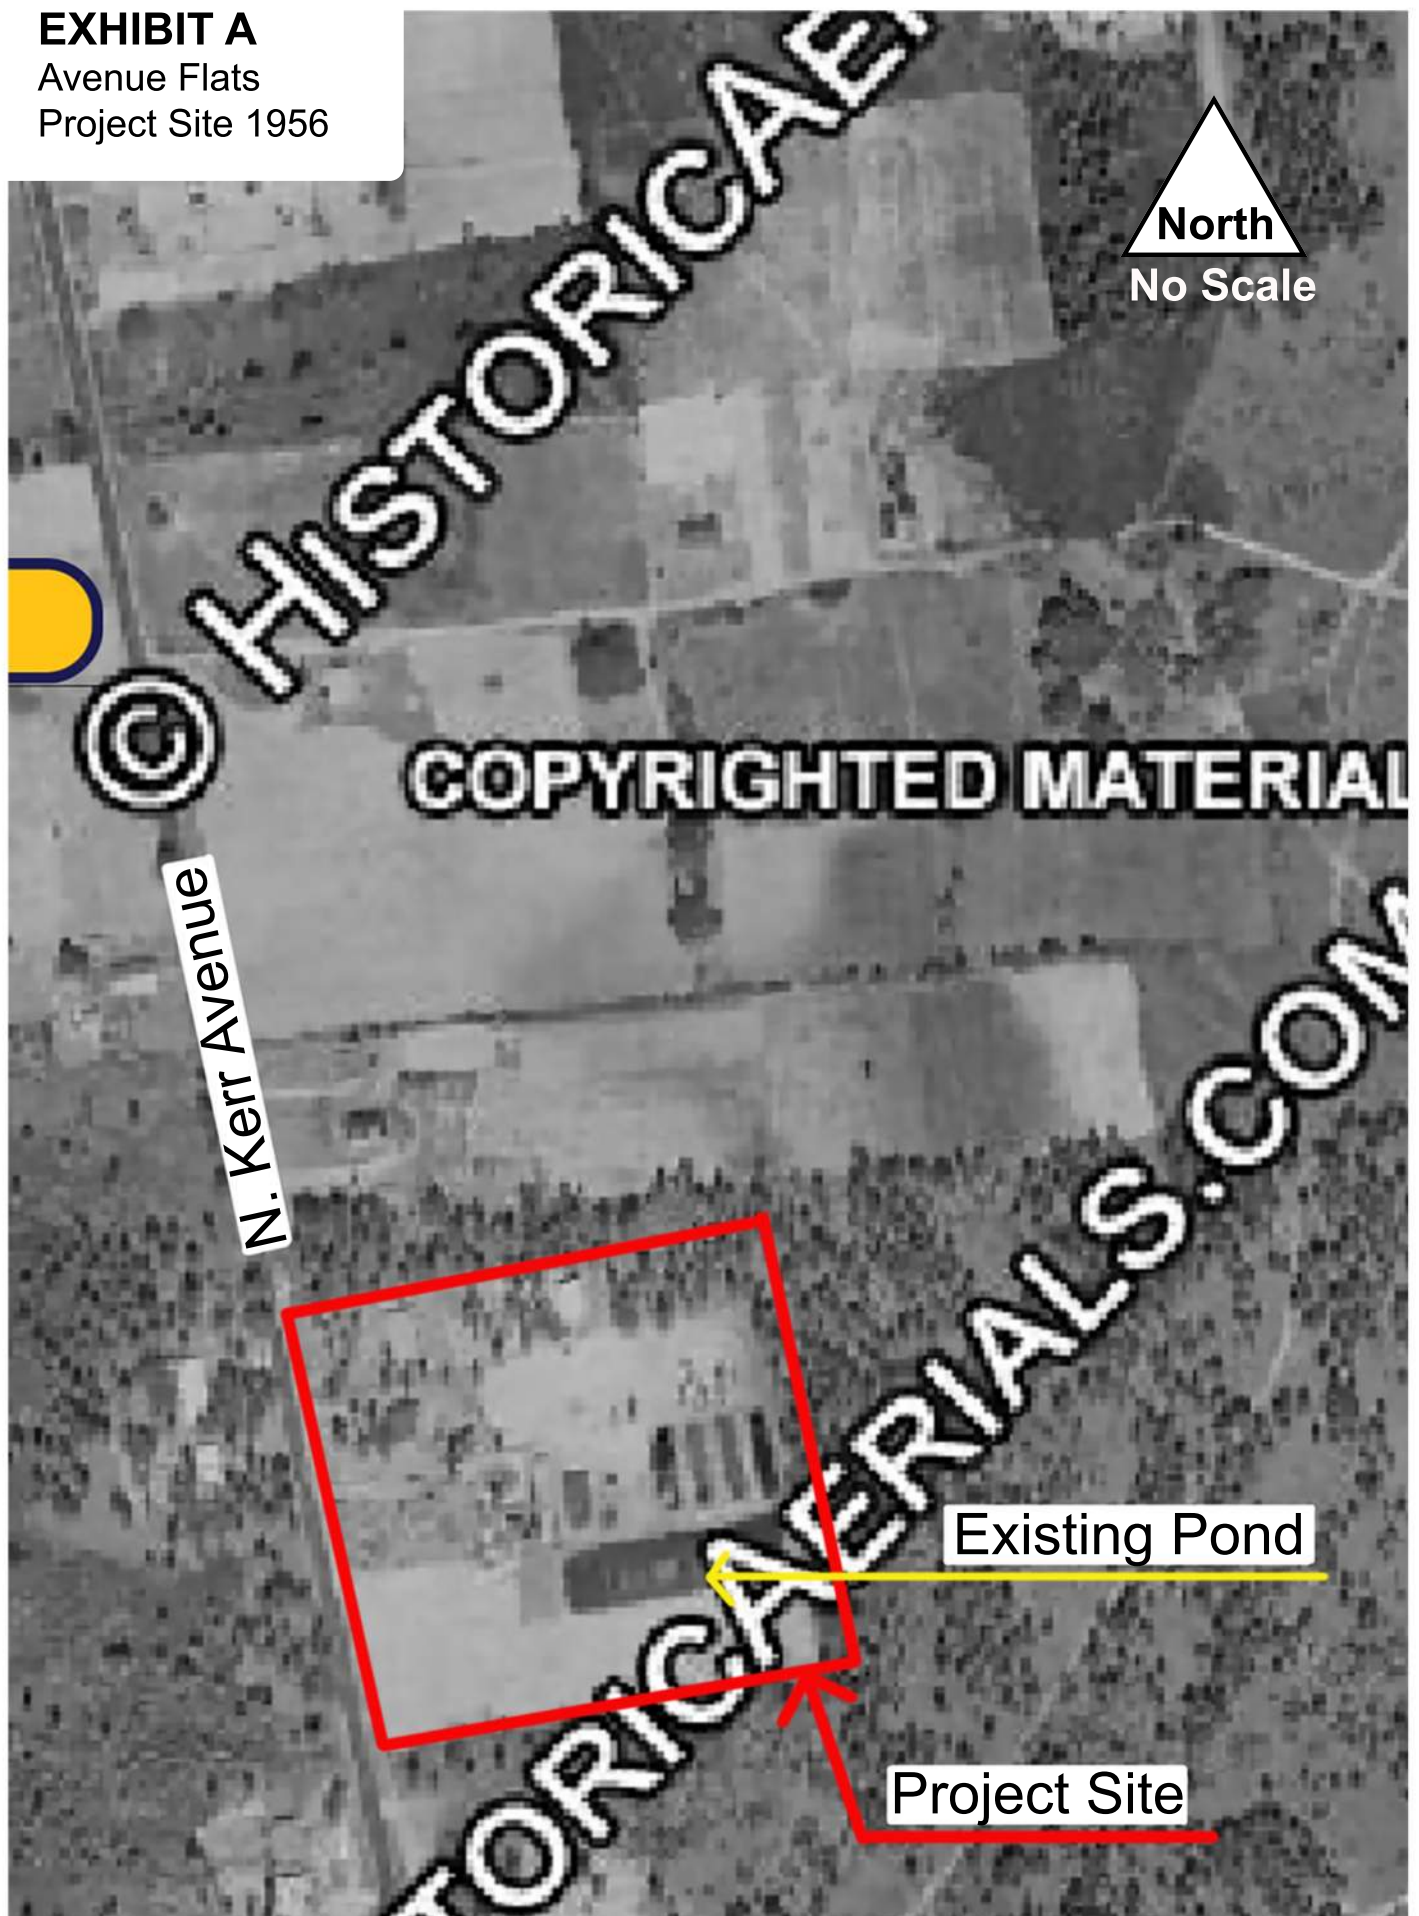
**EXHIBIT A**  
Avenue Flats  
Project Site 1956

**Response:** The subject property was previously used as a commercial nursery, dating back to the historical aerial photo from 1956 (**Exhibit A**). During that time, the previous property owner created a large (20,000 SF) and deep (+/-6’-8’) pond on site for irrigation purposes. That pond remains today and is a man-made topographic condition that is unique and particular to this property. The applicant seeks removal of a 31” Live Oak that is growing on the bank of this man-made pond. As described in the arborist reports, this 31” Live Oak is in poor condition with visible trunk decay and a significant lean away from the sloped bank of the adjacent pond. The tree’s location at the top of the bank has also contributed to the lack of anchoring roots developing on the pond (downhill) side of the trunk, which can be a

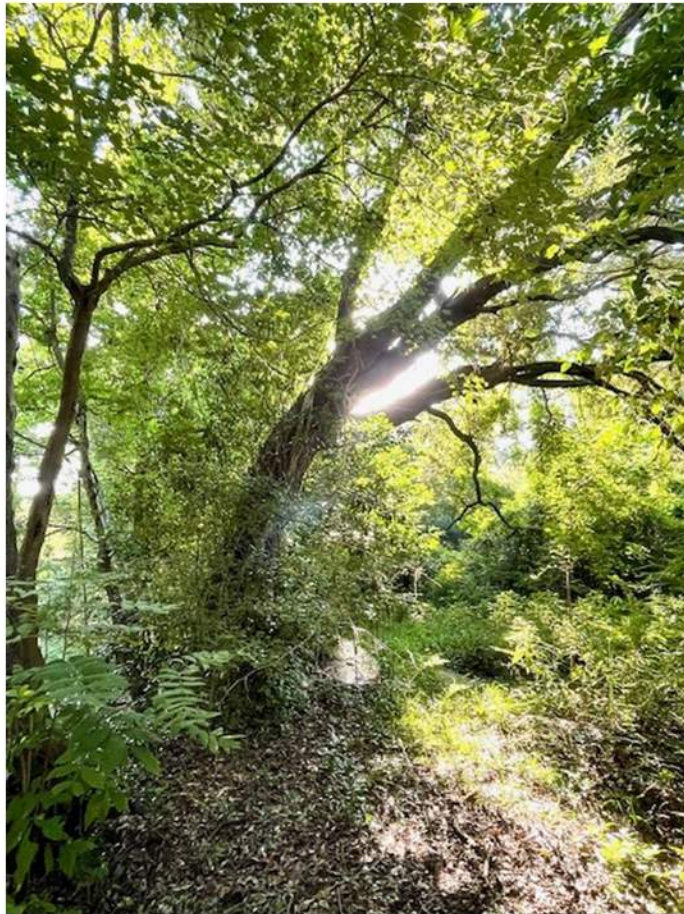
**Photo 1 (Above)** - View of overall tree illustrating leaning growth habit away from the existing pond. The existing pond is to the left of the tree in this photo.

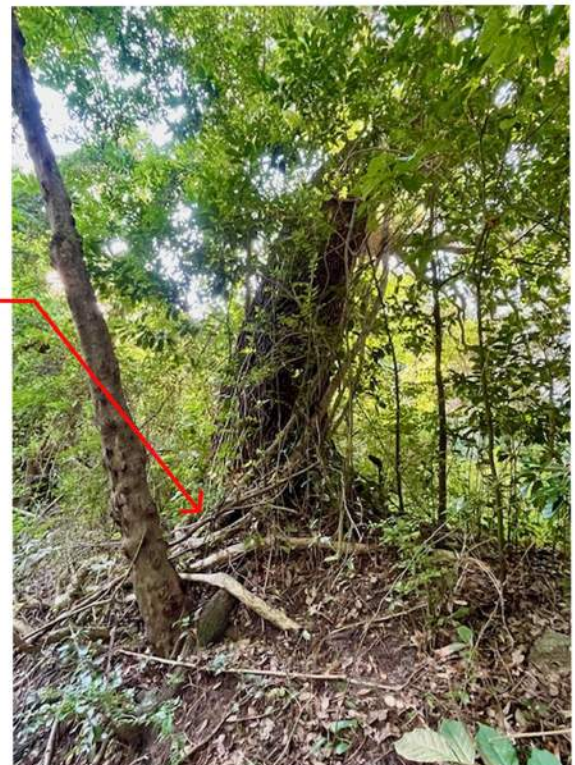
**Photo 2 (Above)** - View of tree from the pond side, illustrating the tree location at the top of bank and growth habit. The steep slopes at pond edge have limited development of anchoring roots at this side of the tree

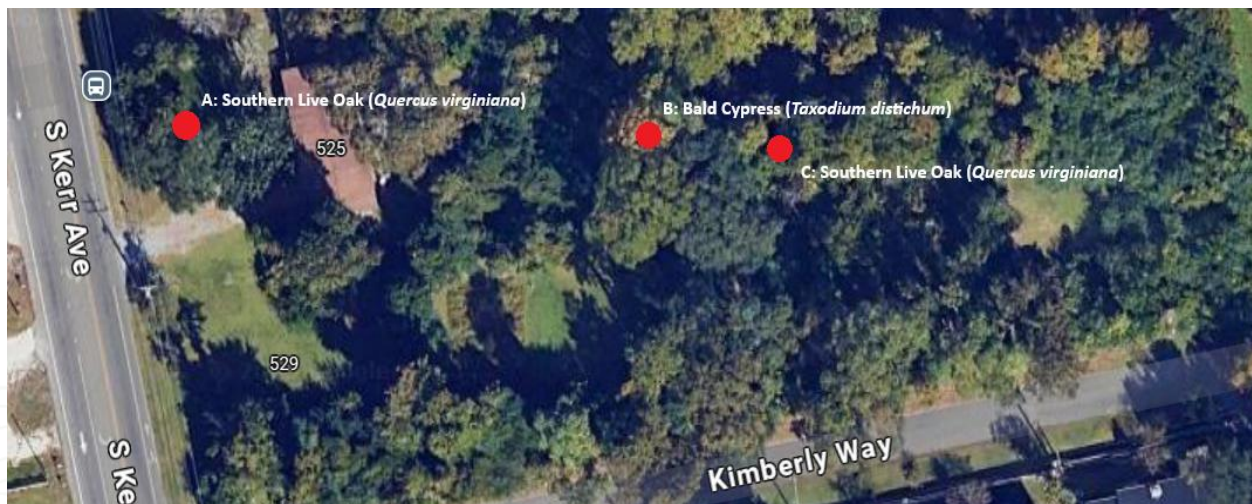
#### A: Southern Live Oak (*Quercus virginiana*)

DBH: 48in  
Height: 32ft  
Crown Spread: 76ft  
Overall Condition: Fair  
Status: Specimen Tree

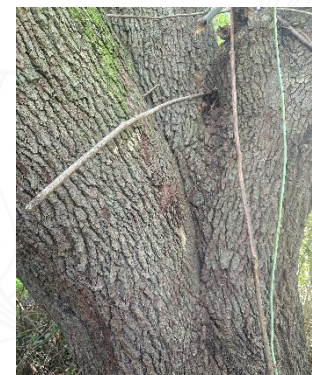
- **co-dominant branches with included bark:** these branches are poorly attached and tend to fail more often than other branches.
- **Missing or decaying wood:** Several locations with decay pockets on main leads and trunk.
- **Fruiting bodies:** located on main stem implying internal decay.

A: Weakly attached Branches

DRG does not recommend the removal and relocation of this tree as it poses too many risk factors to the overall well-being of the tree, with little guarantee the tree will survive. Given the approximate loss of 47% of its root system if it were to remain on site, DRG recommends proper pruning of the roots using an Air-spade system to excavate the roots without causing unnecessary damage and making clean cuts to the roots that are to be removed. DRG recommends general pruning of the canopy to remove all dead and broken branches, as well as thinning the canopy of some of its live branches to compensate for the anticipated root loss. Lastly, DRG recommends soil amendments and fertilization after the work has been completed to reduce stress. This can include a fertilizer with nitrogen, phosphorus and potassium and an additional application of mycorrhizal inoculant. Mycorrhizal fungi are a type of fungi that form a mutualistic relationship with the roots of trees and plants. They colonize the root system and extend their hyphae into the soil aiding in nutrient uptake.

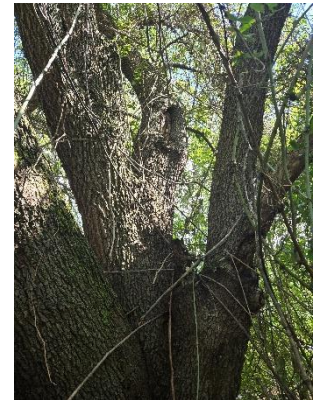
Overall, the oak tree is in a fair condition, there are issues regarding internal decay, weakly attached lateral branches and large dead and broken leads. However, the foliage of the canopy is still rather full with little dieback which indicates a healthy root system and functioning cambium layer able to transport vital water and nutrients through the system to support itself. As per the discussion with the client, Paramounte is expecting the development to cause a root zone loss of approximately 47% if the tree were to remain at its location. Anticipating a loss of 47% it is expected the oak will respond with moderate dieback in the canopy.

A: Missing and Decaying Wood

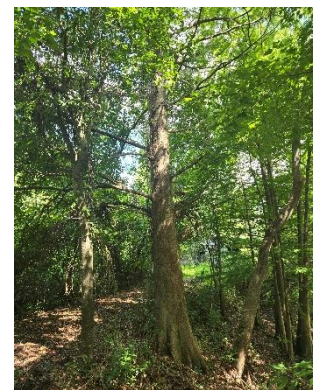
B: Bald Cypress (*Taxodium distichum*)

The Bald cypress is in good condition with minor defects. There are some small dead and broken branches found in the lower half of the canopy however, this is common in similar trees and does not indicate other issues. The trunk does have sapsucker damage nonetheless this damage is negligible and rarely causes significant decline in similar trees. Lastly there are minor girdling roots at the base of the tree which currently does not pose a risk to the health of the tree.

DRG recommends relocating this specimen to a site that is similar in soil type with adequate moisture. If it were to be planted in dry sandy soils this may cause the tree to become shocked and will likely die due to the drastic change of its microclimate and soil type. With relocation or root pruning of any kind DRG recommends proper root pruning with an Air-spade system and clean cuts to the roots that are to be removed. As well as after care with soil amendments and fertilization as mentioned above.

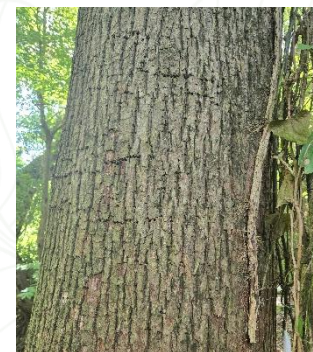
- **Dead and dying branches:** some dead and broken branches located in the lower half of the canopy
- **Trunk condition:** Sap sucker damage located on main stem
- **Root Problems:** minor girdling roots at root flair

B: Sapsucker Damage

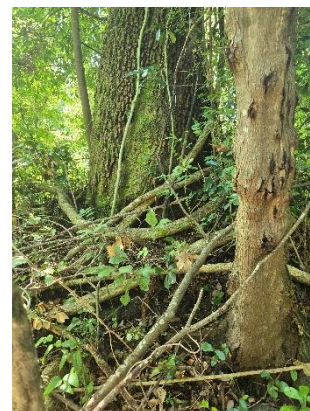
- **Missing / Decaying wood:** There is a decay pocket at the base of the tree on the backside of the lean closest to the pond.
- **Tree architect:** there is a significant lean to the oak
- **Root problems:** The root system is damaged on the backside of the tree towards the pond

The oak located near the pond is in a fair condition with several issues. There is a decay pocket located at the base on the backside of the tree which indicates moderate internal decay. The tree also has a damaged root system and lacks anchoring roots on the backside of the tree (pond side). Also the overall architect of the tree is unbalanced with a significant lean, the lean in general does not necessarily indicate a defect as it could be a phototropic growth pattern however, along with the decay and damaged root system on the backside of the tree this could compromise the structural integrity of the tree and opens it up to the possibility of failure.

C: Southern Live Oak (*Quercus virginiana*) (Backside)

Similar to the Bald Cypress this tree will be adjacent to changes in grading, north of the oak a lowland pond will be filled roughly 6-8ft to make space for a parking lot, additionally on the southern side excavation will occur to install a retention basin. Given these factors if the tree were to remain on site it is likely to experience moderate to severe dieback. Conversely relocating this tree would pose other risks to the health of the tree, based on the condition of the tree relocating is not advisable as the lack of a healthy root system may cause the tree to not be able to re-anchor itself in the new location and would be susceptible to failure and a safety concern to the public. DRG recommends the removal of this tree due to its poor health condition and safety concerns.

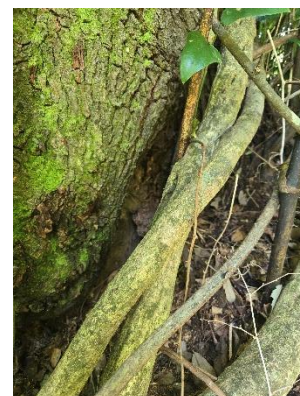
C: Decay Pocket (backside)
