Wilmington Riverwalk

RIVERWALK SOUTH HANDRAILS

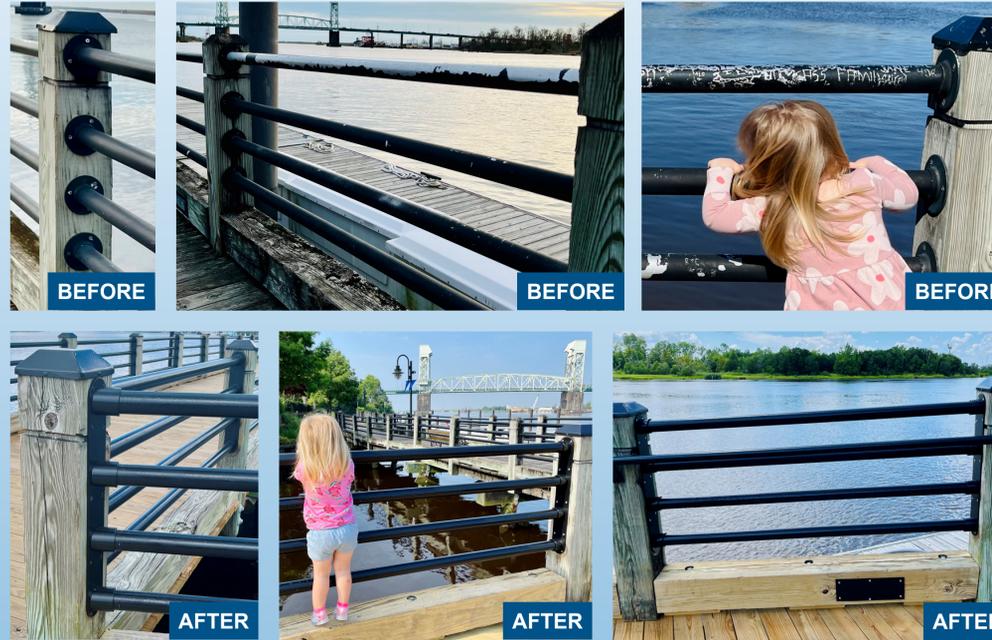
This project involved the repair of the aluminum handrails along the Riverwalk from Dock Street to the southern end. The existing railing system included individual collars to attach each railing to the timber posts and was maintenance-intensive, requiring frequent checking and tightening of set screws to keep the railings in place. This project replaced the individual collars with aluminum plates to secure the railings to the posts and eliminate the potential for loss of railings.

Bids for the project came in low, freeing up funds to add a much-needed railing recoating to the Contractor's scope of work. The railings were recoated with a high-performance paint product, applied in three coats. The type of coating used for the Riverwalk railings is heat-resistant and cures to create a hard, durable finish that can help prevent corrosion.

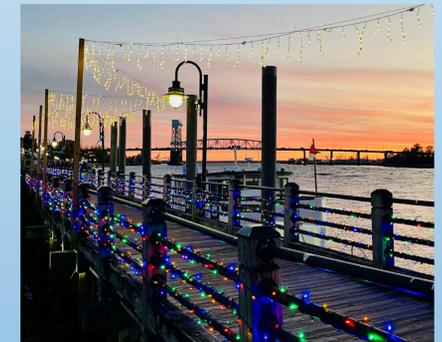
WATER STREET PARK BULKHEAD REPAIR

The existing bulkhead between Princess Street and Chestnut Street was in need of repairs. To improve the safety and structural integrity of the bulkhead, this project included corrosion removal, penetration repairs, and repair of land erosion. A major part of this project was patching holes in the bulkhead which allowed material to leak out, compromising the stability of the bulkhead below the water's surface.

Additional locations in need of patching were found during this project, and the scope was expanded to include these areas. Much of the work was completed underwater as the bulkhead extends below the water's surface.

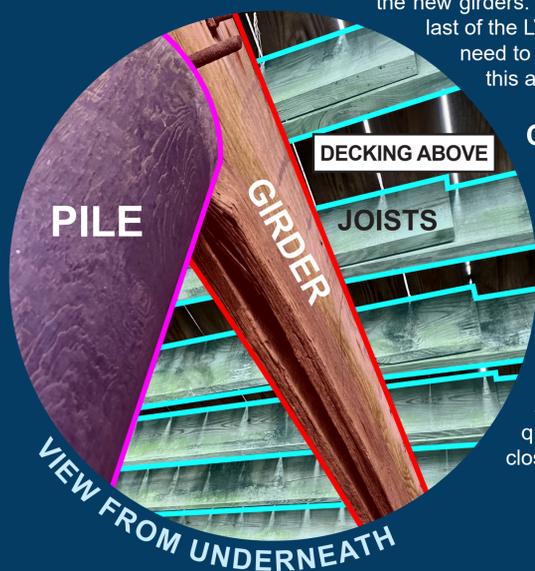
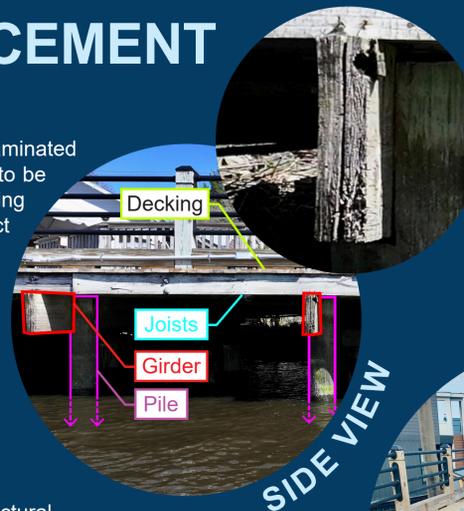
RIVERWALK SOUTH PILING AND GIRDER REPLACEMENT

To maintain the structural integrity of the Riverwalk, aging laminated veneer lumber (LVL) girders have been and are continuing to be replaced. The LVL girders come apart over time and are being replaced with solid timber girders. This particular project includes the replacement of six LVL girders near Elijah's. Additionally, the existing piles must be modified to accept the new girders. These are the last of the LVL girders that need to be replaced in this area.

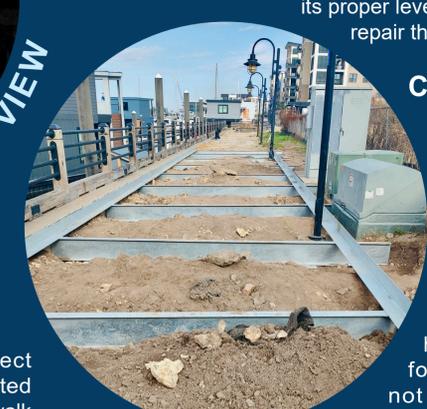
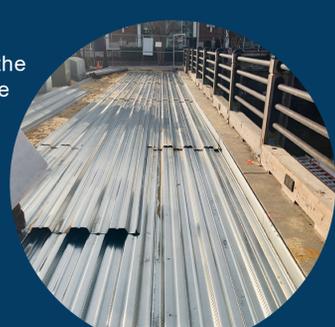
RIVERWALK NORTH FOAM INJECTIONS

A section of the concrete Riverwalk near Port City Marina had gradually settled over time. A geotechnical and structural review found that the bulkhead is stable, but the soil between the bulkhead and the Pier 33 development settled more than expected. This caused parts of the Riverwalk to sink, creating trip hazards and areas where water could collect. To fix the issue, expanding foam was injected to fill gaps, stabilize the soil, and raise the walkway back to its proper level. The foam injection method is unique as it allows us to repair the Riverwalk without removing the existing surface.

Some sections of the Riverwalk had to be removed to install helical piers where the foam injections were not successful, and to allow for rerouting of existing utilities.
