## CASE SUMMARY • CERTIFICATE OF APPROPRIATENESS (COA)

Historic Preservation Commission Evidentiary Hearing • September 11, 2025

| <b>Address:</b> | 501 South 5 <sup>th</sup> Avenue | <b>District:</b> | Historic District-Residential (HD-R) |
| <b>Request:</b> | Exterior Alterations; chimney removal and replacement, exterior door removal on rear façade and replacement with window, side exit door removal and relocation | | |

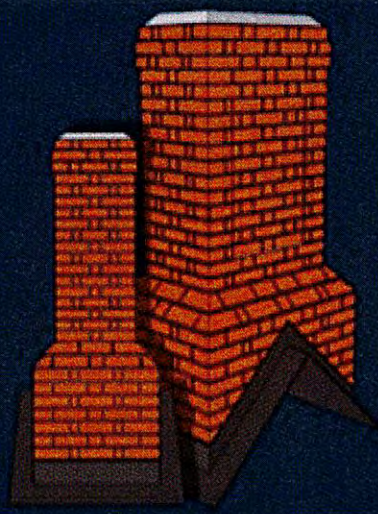
BRICK CLAD

- Offered in brick, stone and render finishes, using exactly the same material being supplied to the property
- Finished with traditional style caps and pots or bespoke detailing when required
- Suitable for Class 1 and Class 2 twin wall flue systems
- Constructed in factory conditions to be pointed on-site and lifted into position on the rafter trusses

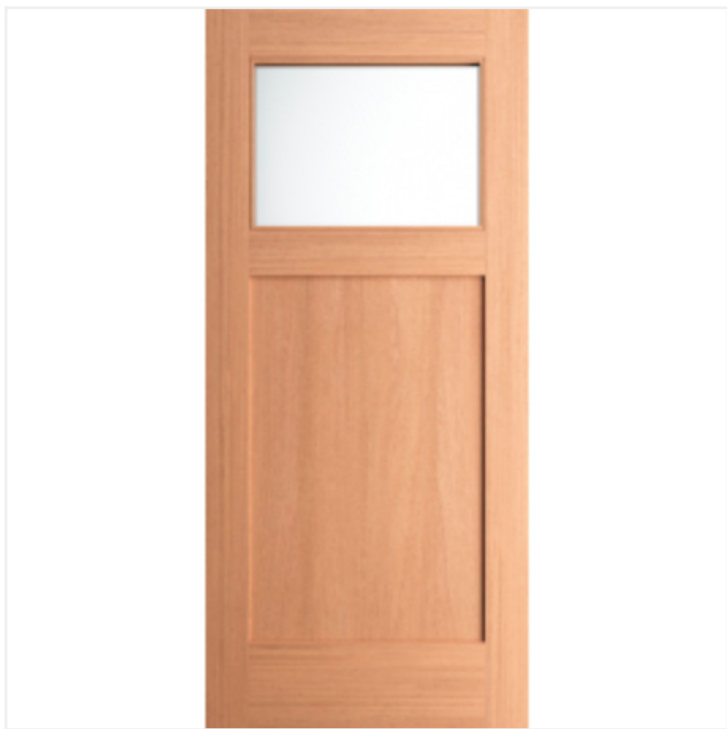
**Low-E Glass:** Dual tempered low-e glass combined with our exterior mahogany doors reduces noise, air conditioning and heating bills.

**Pre-hanging:** Our solid core mahogany Exterior Mahogany doors can be pre-hung for interior or exterior applications with matching engineered mahogany jambs or finger joint white primed jambs as pre-hung single doors or pre-hung double doors units. Side-lites are also available.

**Impact Hurricane Certification:** Our Exterior Mahogany Craftsman doors are available with a Miami Dade hurricane impact wood door approval in both in-swing and out-swing configurations. Our wood Exterior Mahogany storm doors certifications are equivalent to a "Miami-Dade NOA" the highest hurricane approval standard for wood doors in the country. Each of our mahogany Exterior Mahogany doors can be assembled with the appropriate components to be Florida Building Code Compliant.

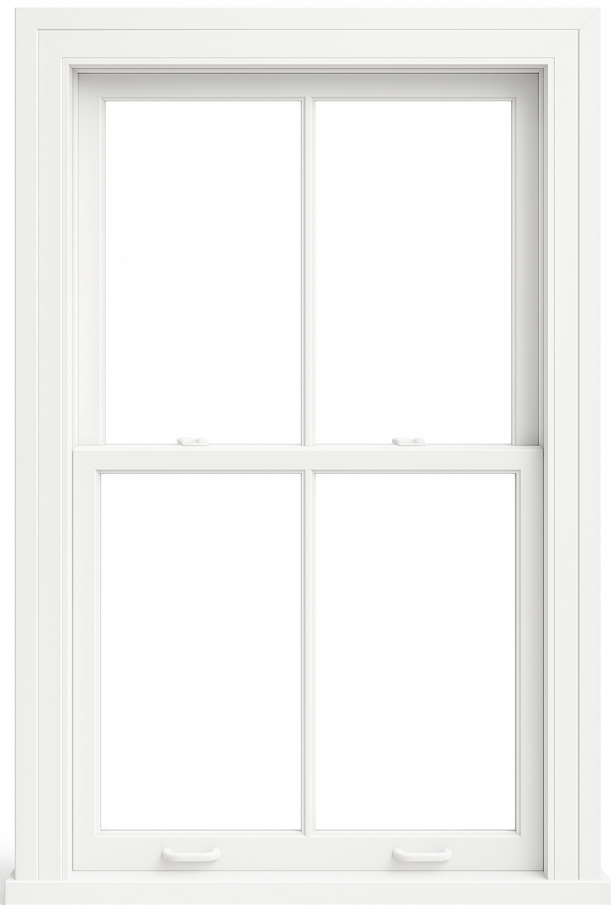
# Manufacturer Custom Window Specifications

Product Series: Solid Pine Single Hung Window

- Sound Insulation: Rated at 36 dB (lab-tested)
- Water Tightness: 450 Pa resistance
- Wind Resistance: 4500 Pa certified
- Thermal Performance (U-Value): 1.1-1.8 W/m<sup>2</sup>-K depending on configuration
- Durability: Suitable for high humidity and coastal applications
